ASA/NAPDRT Aluminum Study

Final Report

June 1, 2016

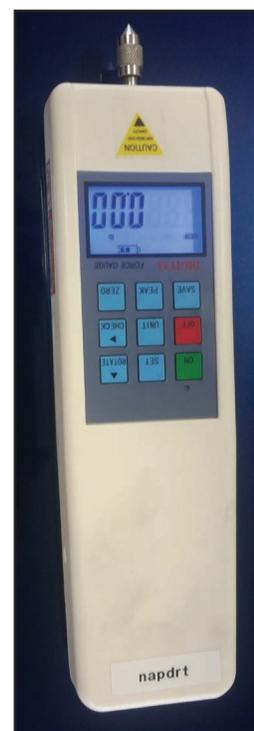
Force gauge used in aluminum repair study.

Samples of steel and aluminum hoods from both import and domestic vehicle models were acquired for the study. Working under controlled conditions at an OEM training center, both types of hoods were set up on horizontal fixtures simulating the typical attitude of the panels in service. Using a force gauge, pressure was applied to indent the panels at various levels of force to simulate hail damage, creating uniform damage areas that were measured and recorded. PDR methods were then applied, and the resulting force and

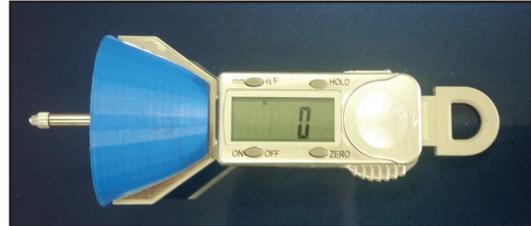
Precision depth gauge used to measure damage.

The average damage depth at 45 pounds pressure on the aluminum hoods was .0033 inches. The average damage depth at 45 pounds pressure on the steel hoods was .0083 inches.

The average damage depth at 75 pounds pressure on the aluminum hoods was .010 inches. The average damage depth at 75 pounds on the steel hoods was .017 inches.

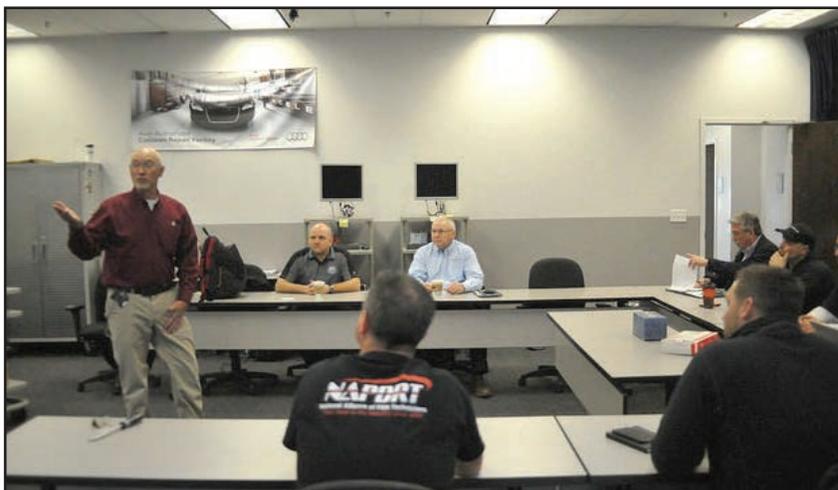
Warren Barbee, VW collision trainer, explains the differences between the different grades of aluminum to study participants.

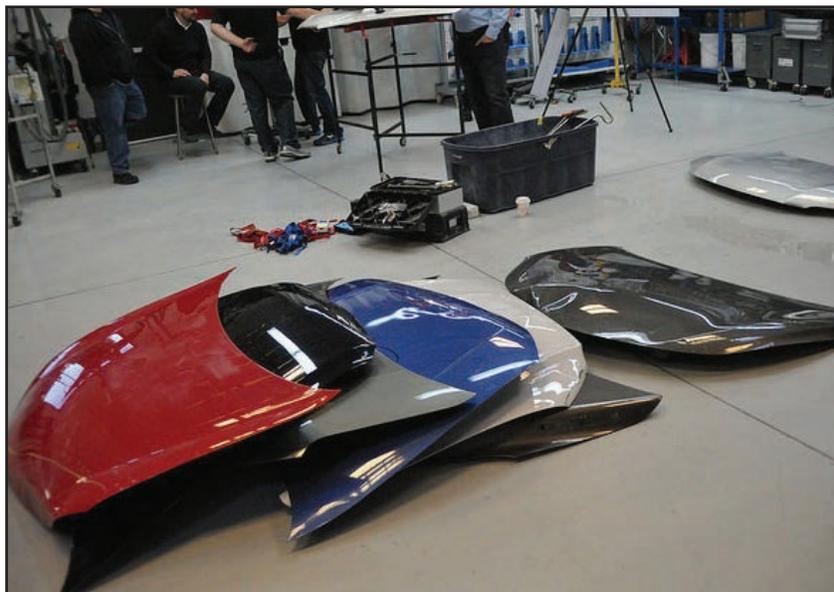
A variety of aluminum and steel hoods were used from both import and domestic manufacturers.
